Green Lake County's Inspection Report

1. Type of Inspection (check all that apply) ☒ Annual ☐ Major Storm ☐ Site
2. Date of Inspection: 10/29/2025
3. Drainage District Name or Number: Seneca-Warren
4. Location of Damage or Complaint:
Looked at Junction of Town Drain and Lateral A, concern from Mike Eagan that his water cannot get into the Town Drain to provide drainage.
5. Name of person(s) making complaint or accompanying the inspection:
Mike Eagen, not present for inspection

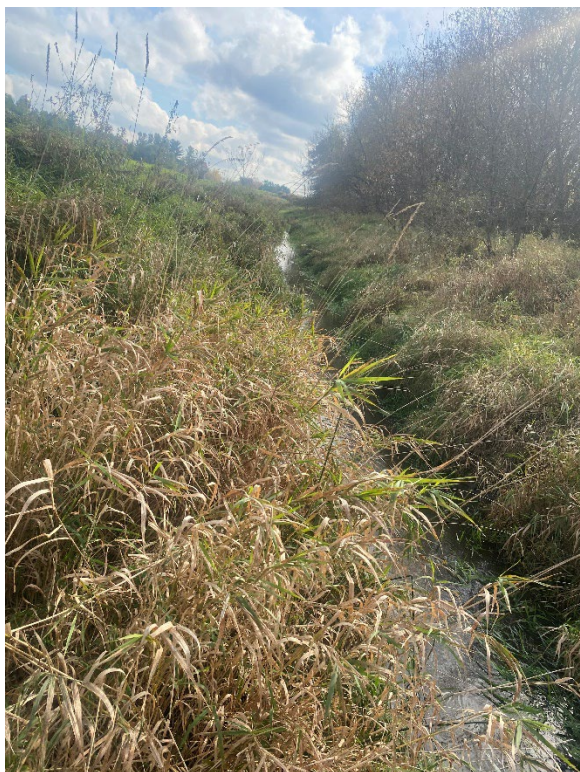
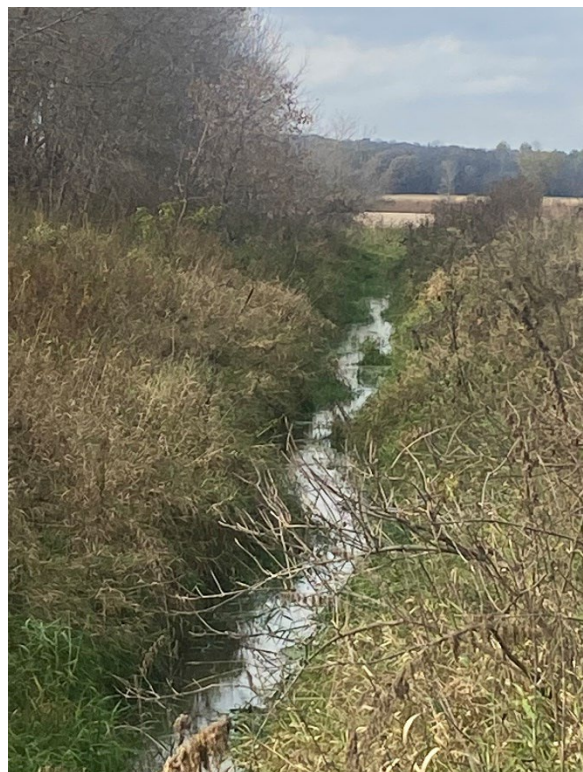
Thomas Guden, Question on time of year for inspection, impact on deer hunting, Thomas Suggested Spring is better. Then he wanted me to look at trees in corridor.

Ditch/Trees – along corridor (Guden property)

Overall, I think the ditch is working and depth is to specification.
Brush and tree removal in corridor should continue with a section or percentage done every year. Annual spraying of woody vegetation till grass crowds out.

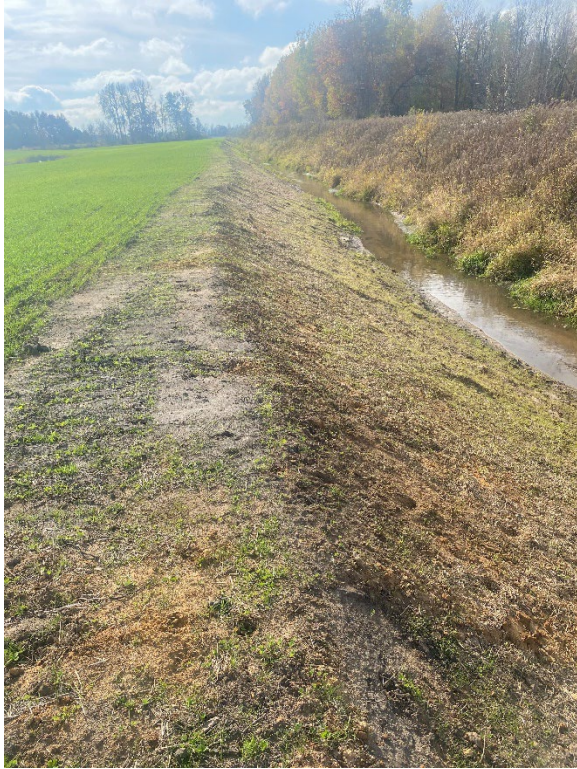
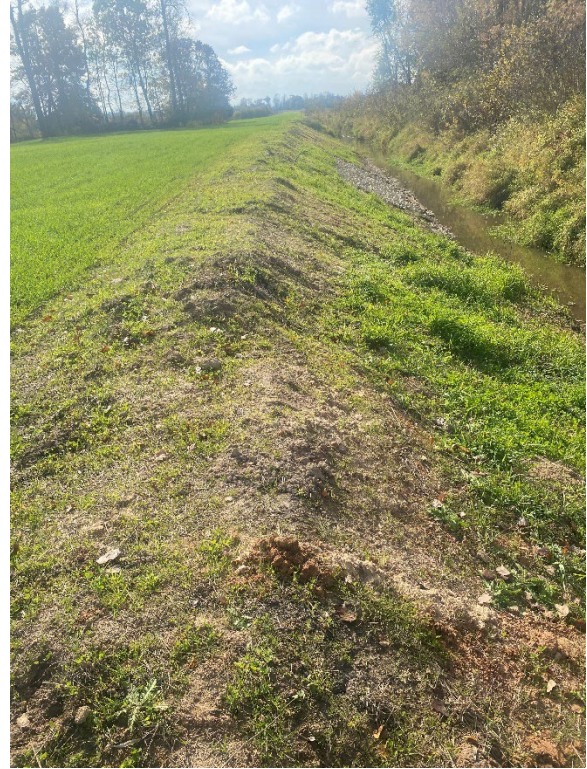
After that I called John Shrock 10/28/2025 asked about any concerns, he said no as erosion but seeding did not look that well. But the two projects along the land he farms looked good. I did not look at Double E But a month earlier at 26th Ct Ditch is good. But brush and tree from brush cutting a couple years back have great roots and are growing strong.

Schrock Bank Repair

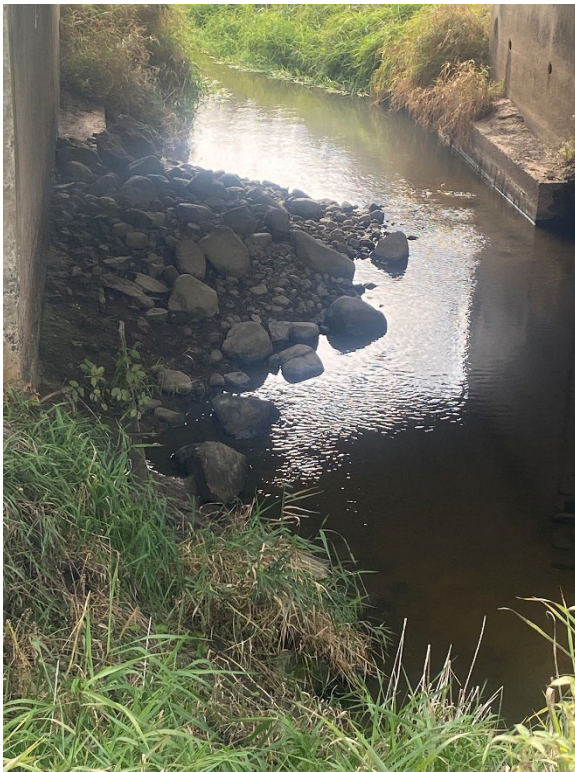
Rocks under Hwy E

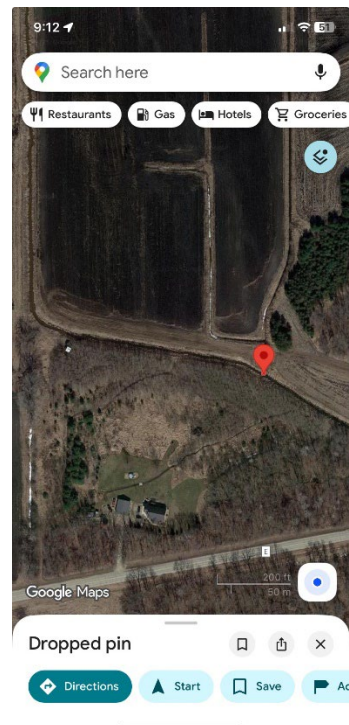
7. Repairs Proposed or Action to be Taken by Board (attach additional sheets if needed): No action needed at the junction of Town Drain and Lateral A at this time. Bottom is at design elevations. Zietlow did inspect portions of ditch on own and took photos, one concern area is on Schrock property, approximately at station 284+54.

Area of Concern – 284+54

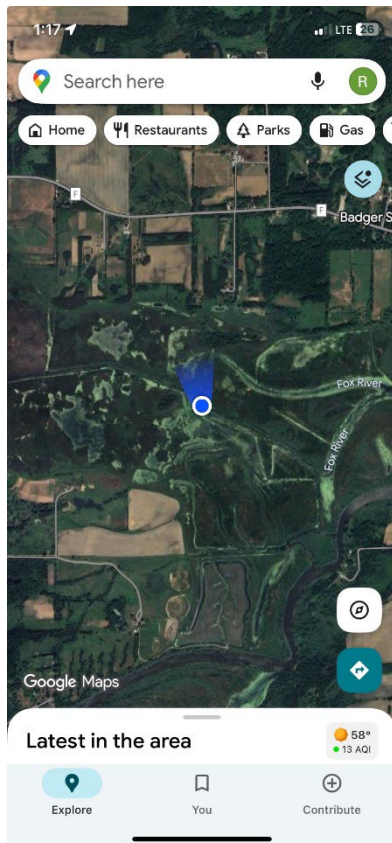
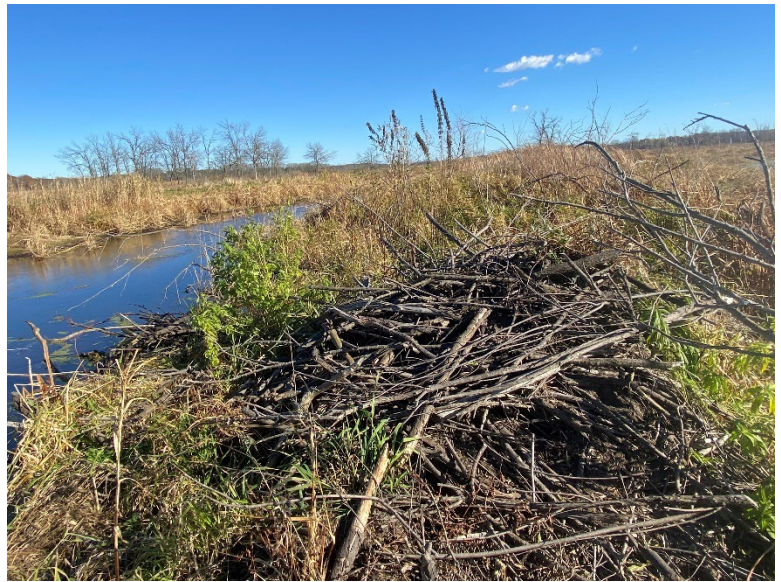
Town Drain inspection – East of Hwy D (Kujawa access point)

Paul Kujawa, I called to find out what has progressed with his project that he discussed at our June meeting. Inspected that with his permission 11/03/2025. 90 minutes
Two areas are now plugged in the corridor to help hold water on his property. There is another large opening upstream in the ditch corridor that is above the bottom of ditch and higher than current water level to help supply his wet land area. The Kujawa private lateral that runs parallel to the town drain in my observation can no longer reach the river. It's possible there's a culvert or structure I did not see. So, water likely would have to come back into the Town drain to exit.

Kujawa's also concerned about the major amount of wild rice growing in the ditch. I did not see any that plugged the ditch, but maybe it went dormant or destroyed from mud motors.

No grass found in Town Drain.

Tree in close to where dam was last year. Water is flowing. Some debris here and there. Water flowing ok. Zietlow did not see any wild rice blockage.

Zietlow counted 25 trees from access to where south ditch bank is washed through, not plugged upstream from improved dike. There has not been any work on South bank except to plug two holes. Water can still flow through major washout in south bank and is then trapped south of ditch corridor.

The plan I heard from the Kujawa's Petrazak will be back in December to do more work for them. At that time Petrazak could do any work in that area we need done. Like the 25 dead trees taken down. Or more debris removed from the ditch channel.

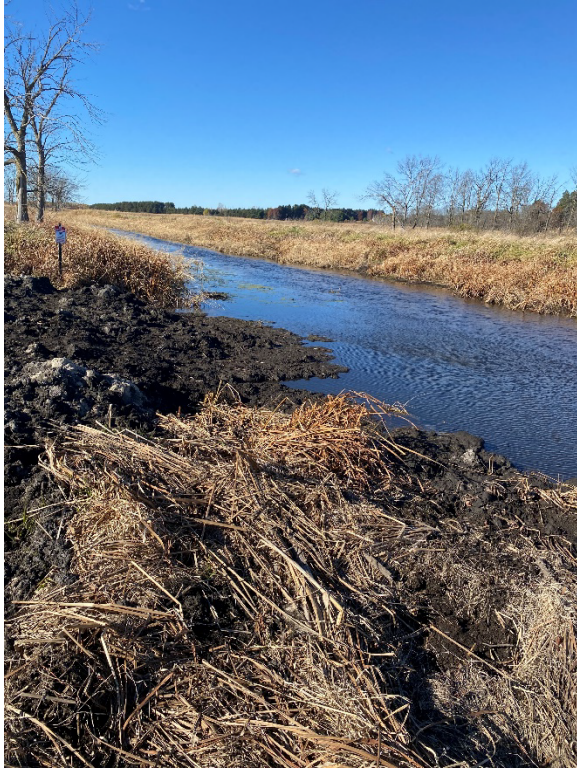
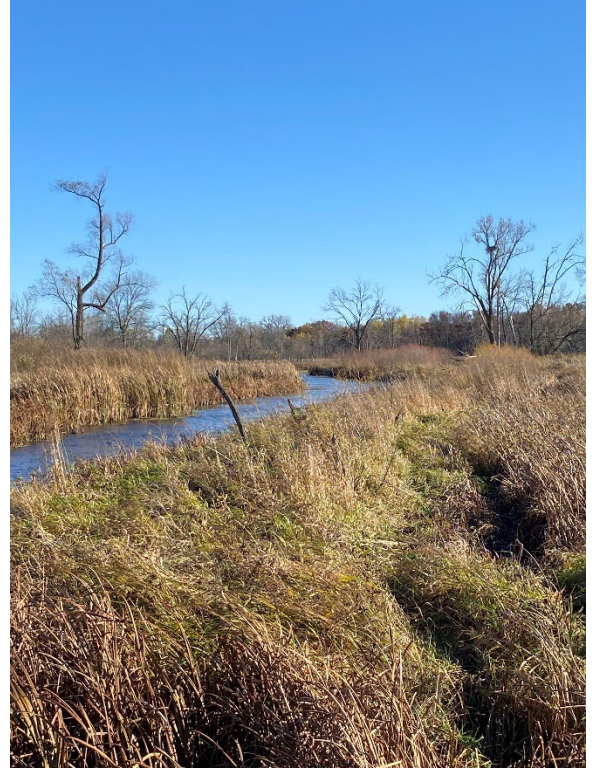
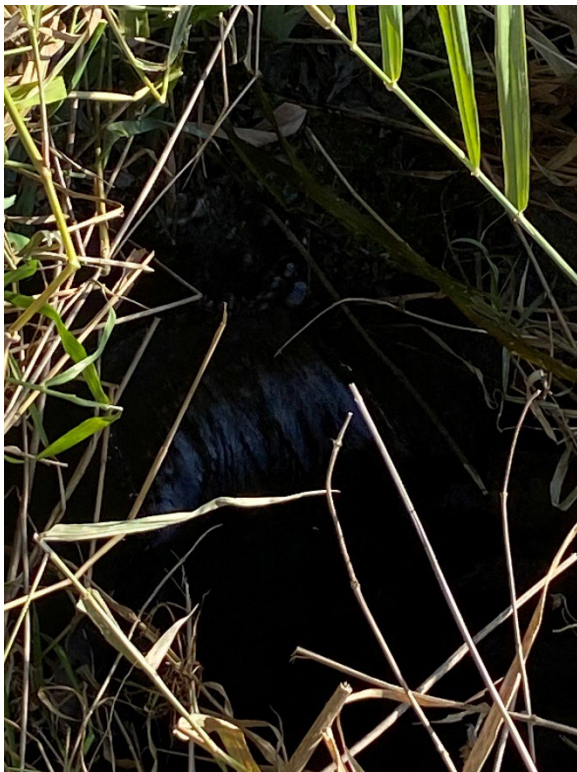
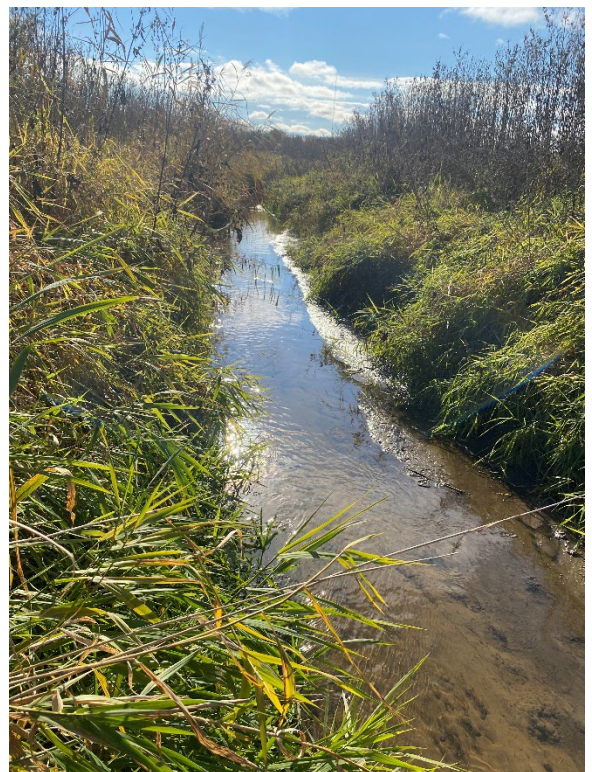
Lastly, I again looked at the inspection culvert between Verch and mine the Zietlow land on 11/01/2025 its 10-12 inches to high holding back water in the Verch Schrock, Zietlow ditches. Needs to be lowered.

Corridor culvert Zietlow land and private lateral between Zietlow and Schrock

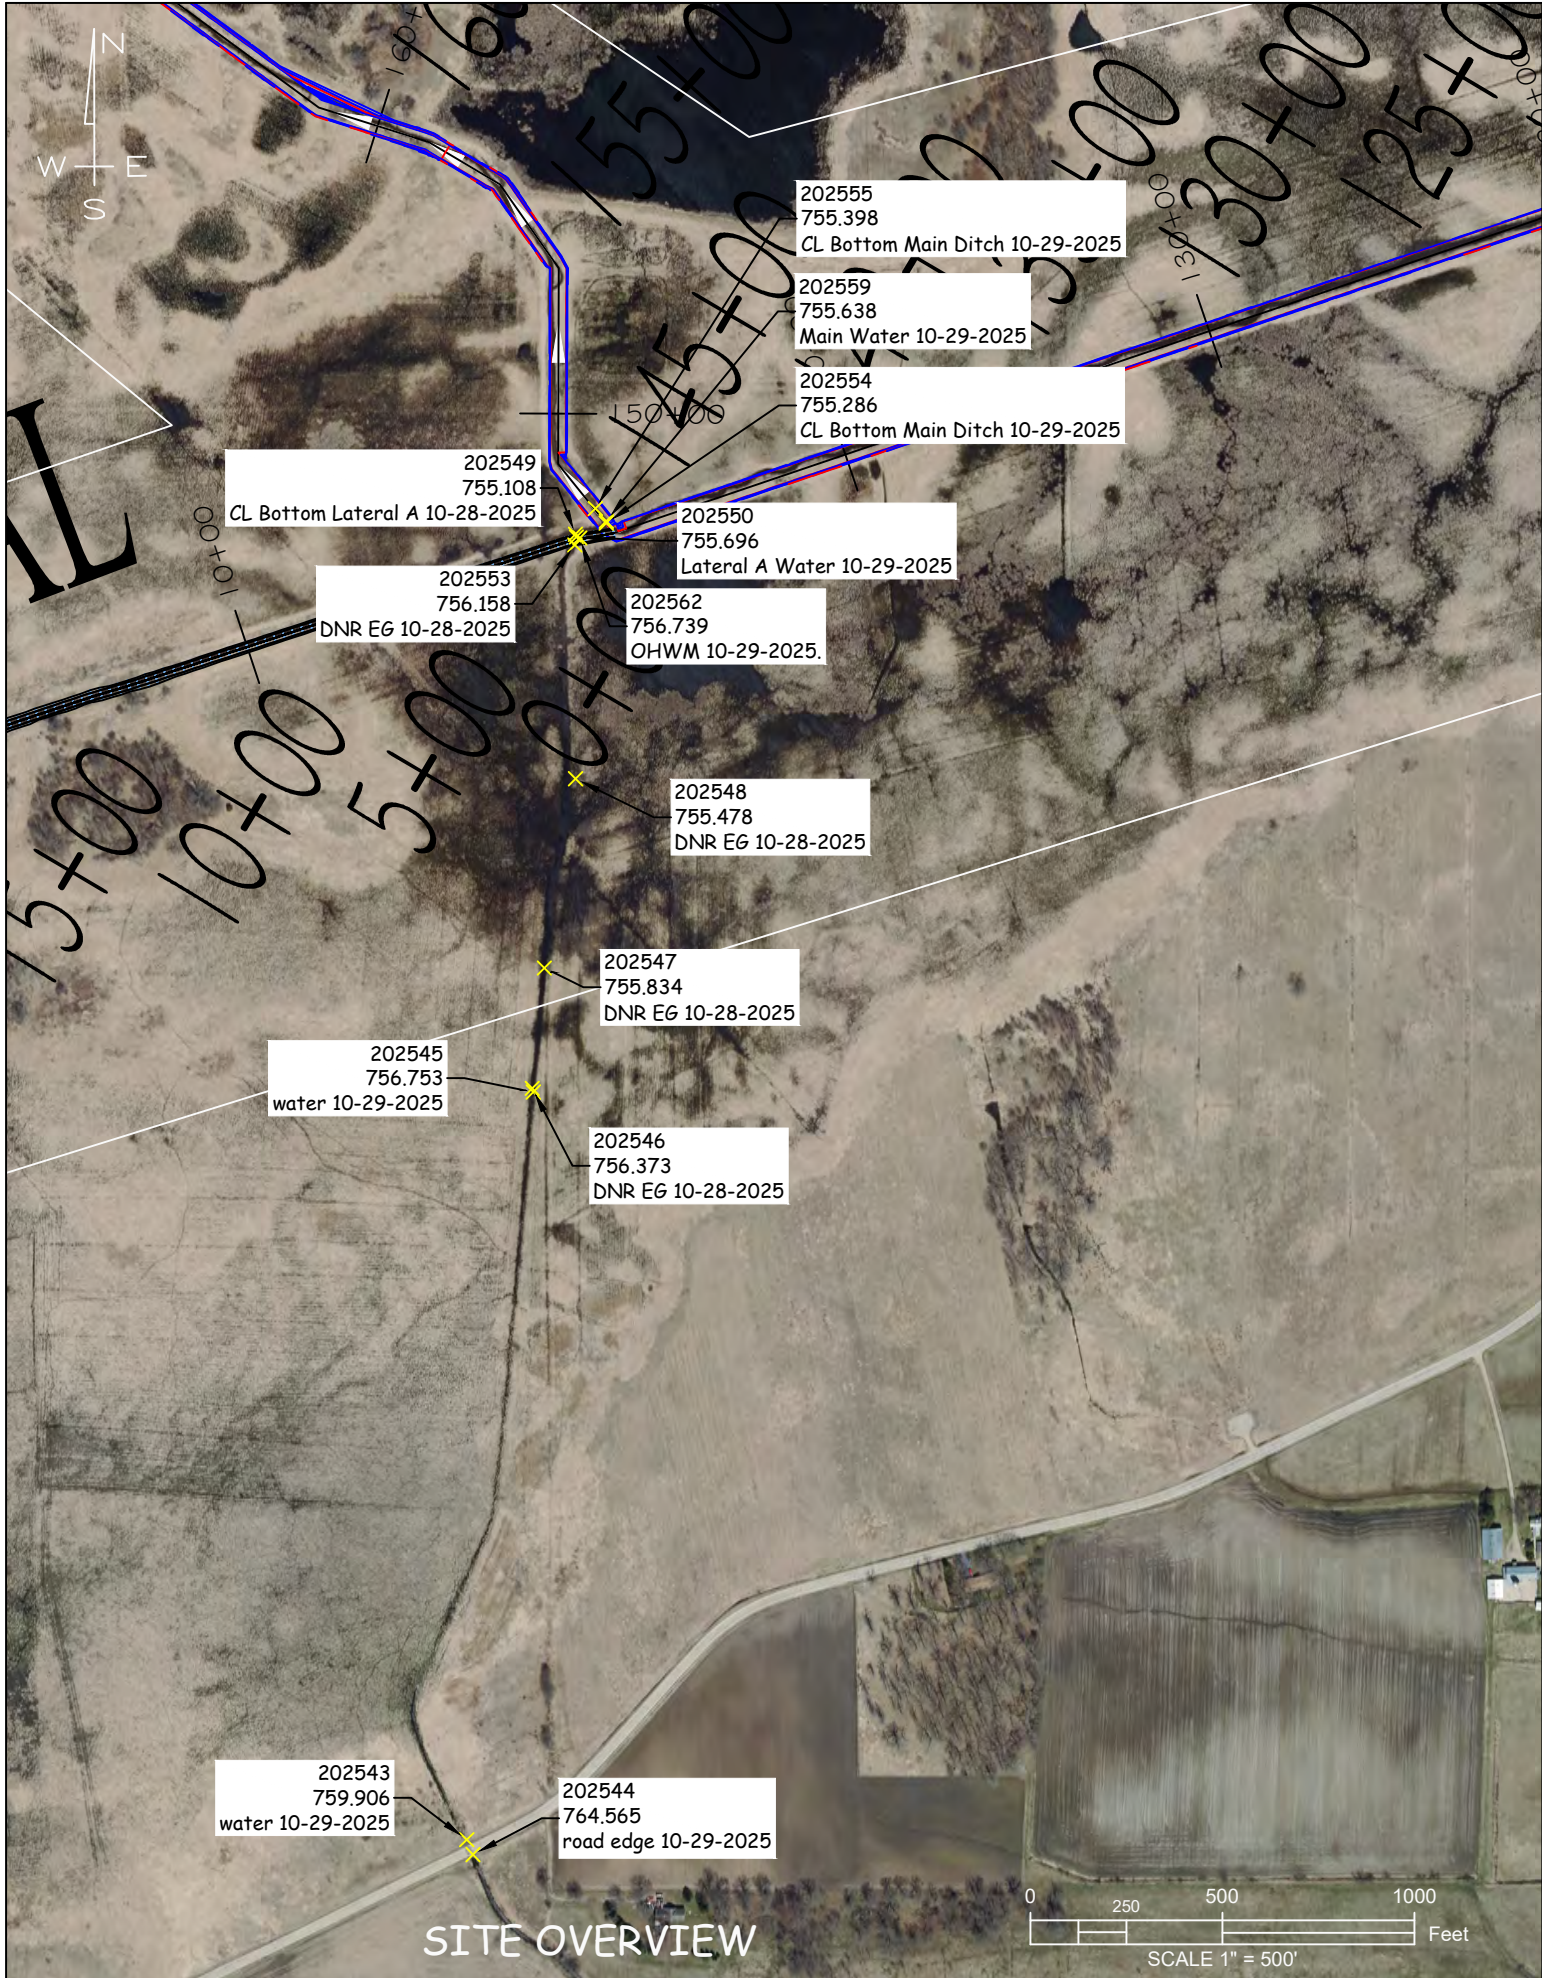
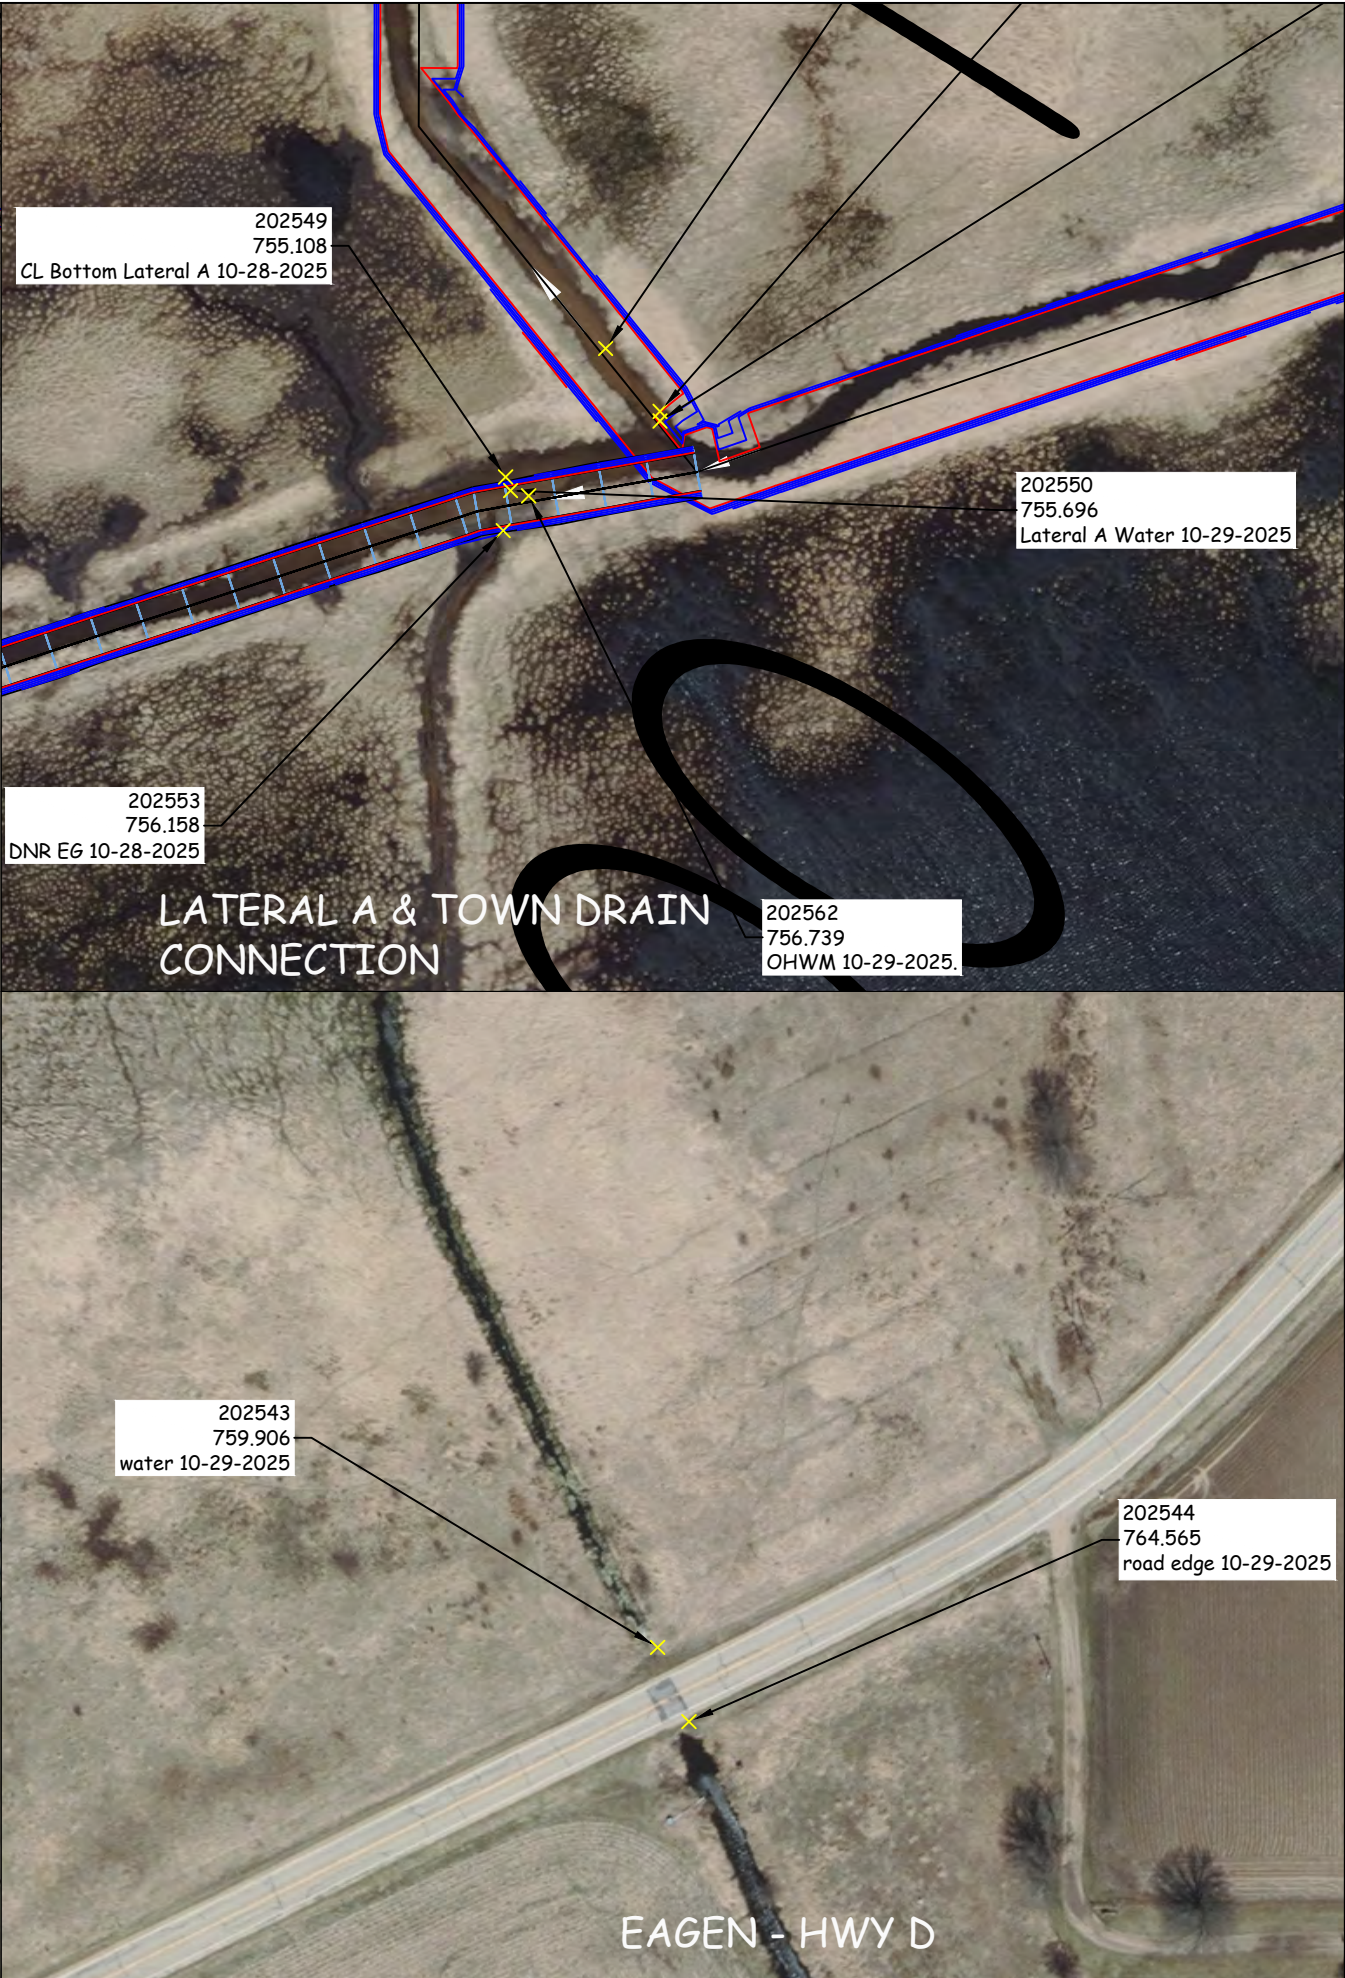
6. Description of Damage (attach additional sheets if needed): Green Lake County Emlid Survey Grade GPS used during inspection to document elevations of water and ditch bottom. DATCP approved ditch surface is loaded into GPS so any elevation concerns are known in the field during inspection.
