Lake Puckaway's  
**Vanishing Act.....**

# A lake of many cultures.....

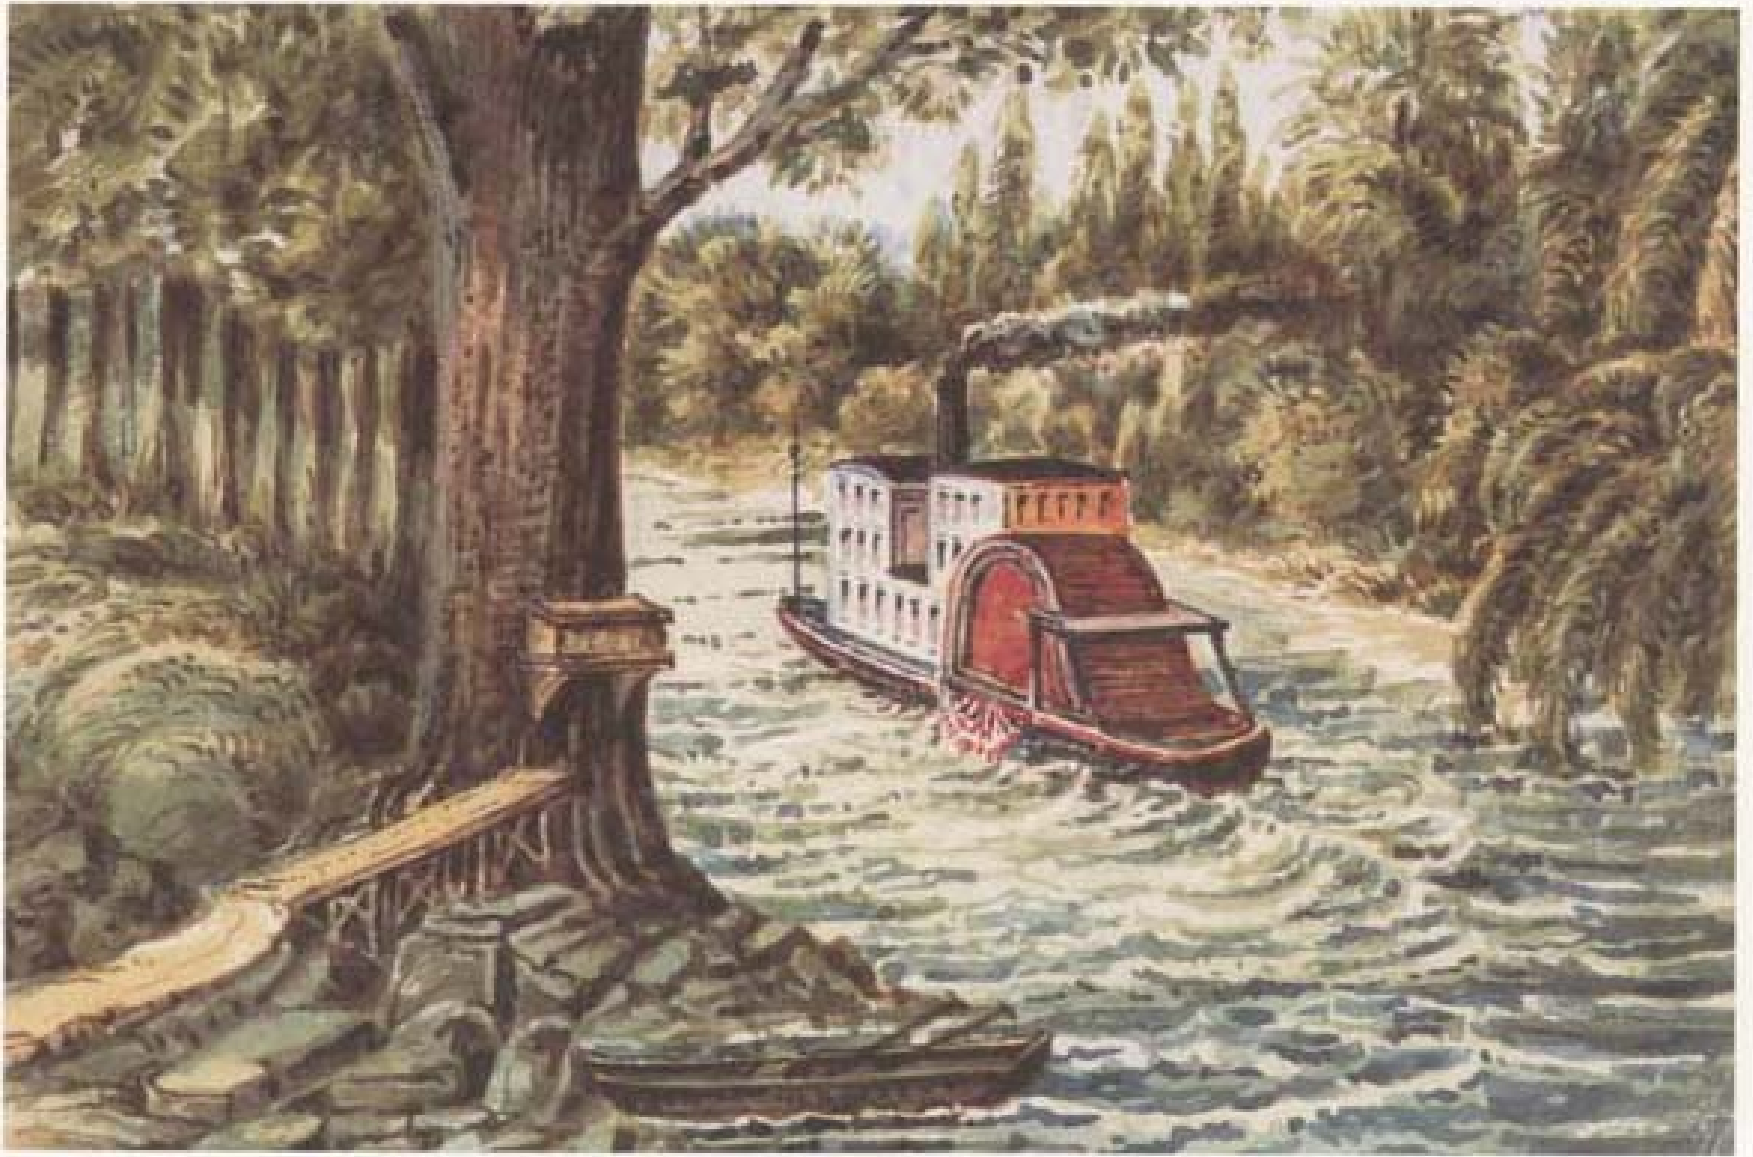
The Princeton Dam was built by the Army Corps of Engineers in 1897 in an effort to provide water deep enough for commercial freight steamers.

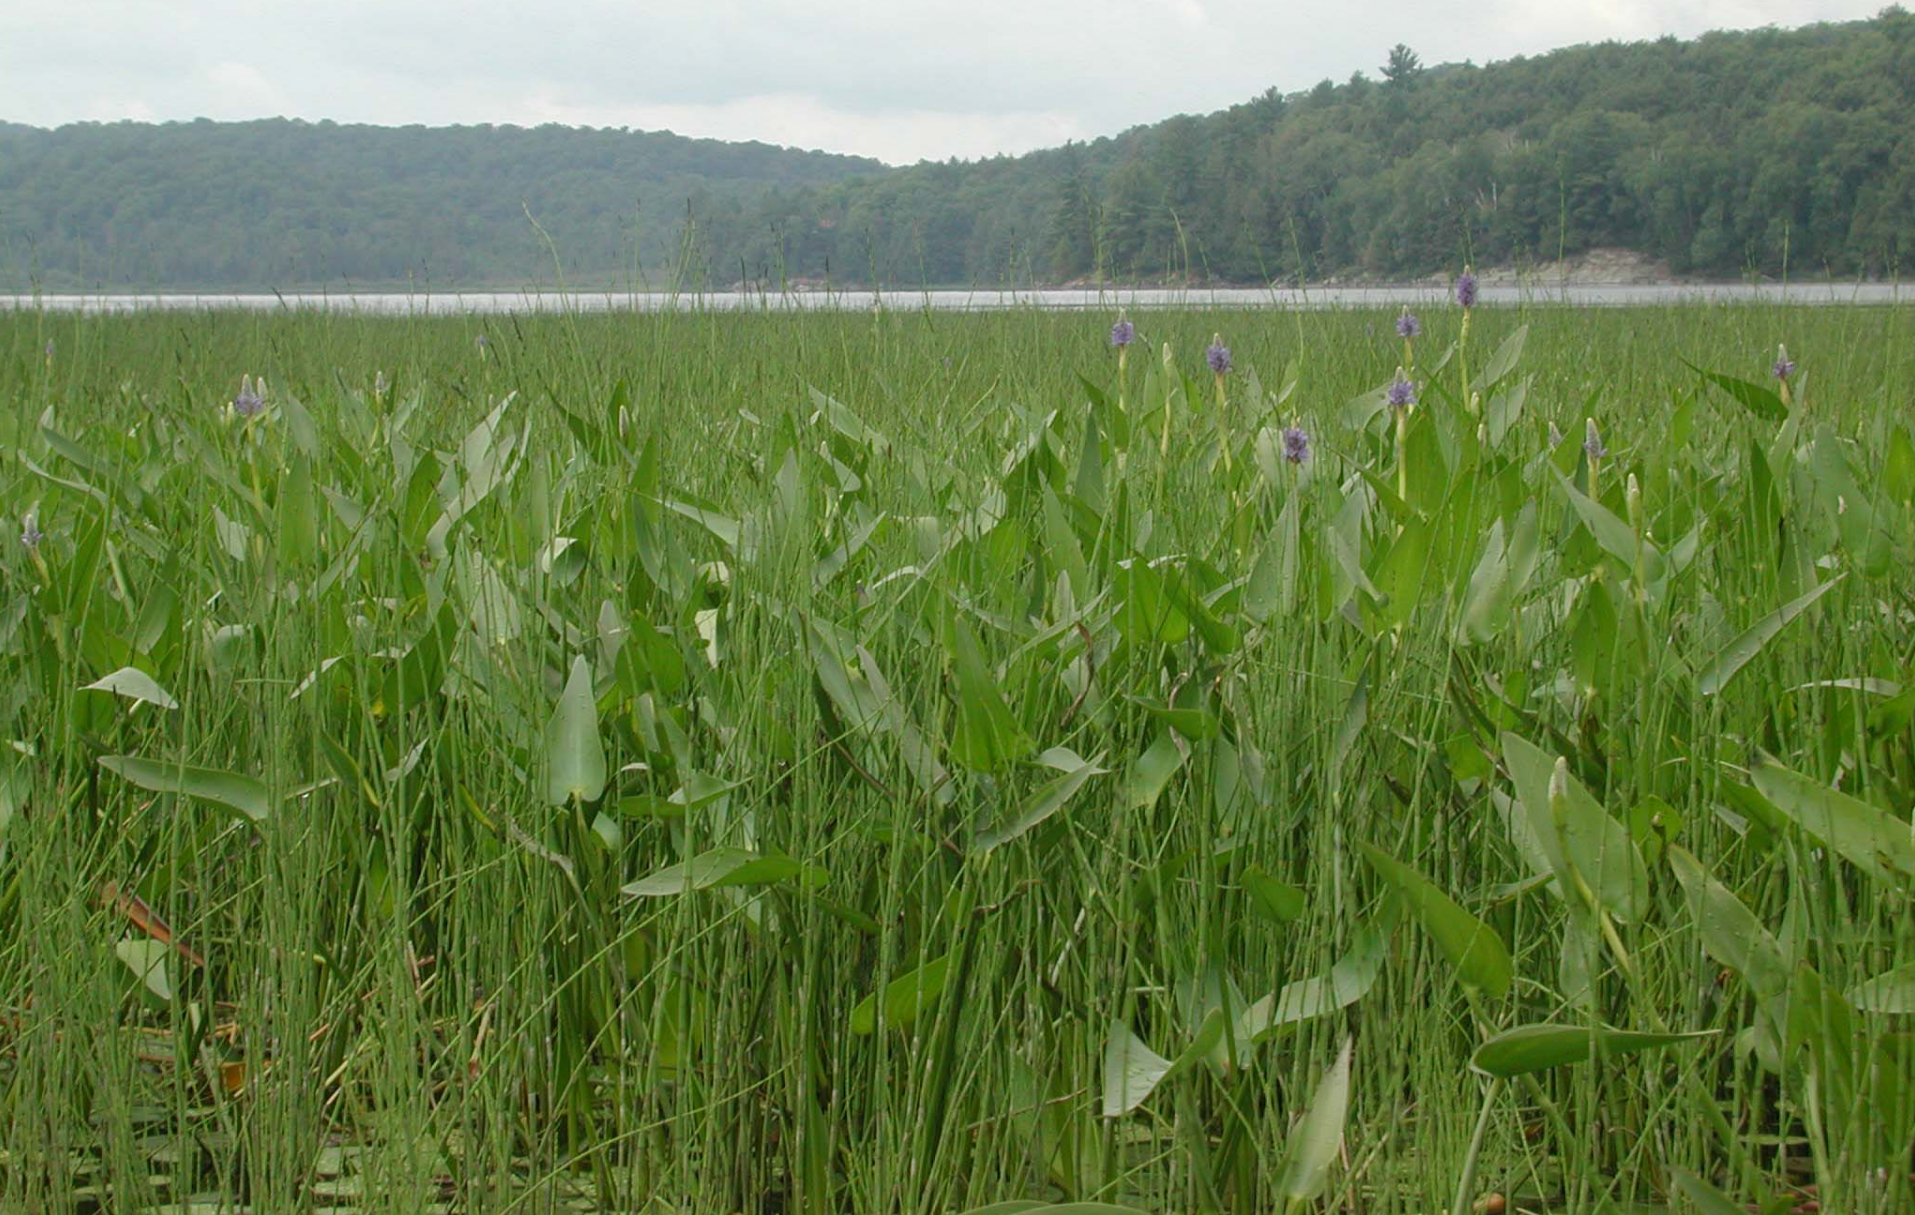
1946 SOUNDING SURVEY BY U.C. O'HAN

NOTE:  
 SOUNDING SURVEY MADE BY U.C. O'HAN  
 IN THE SUMMER OF 1946  
 AND IS NOT TO BE USED FOR ANY OTHER PURPOSE

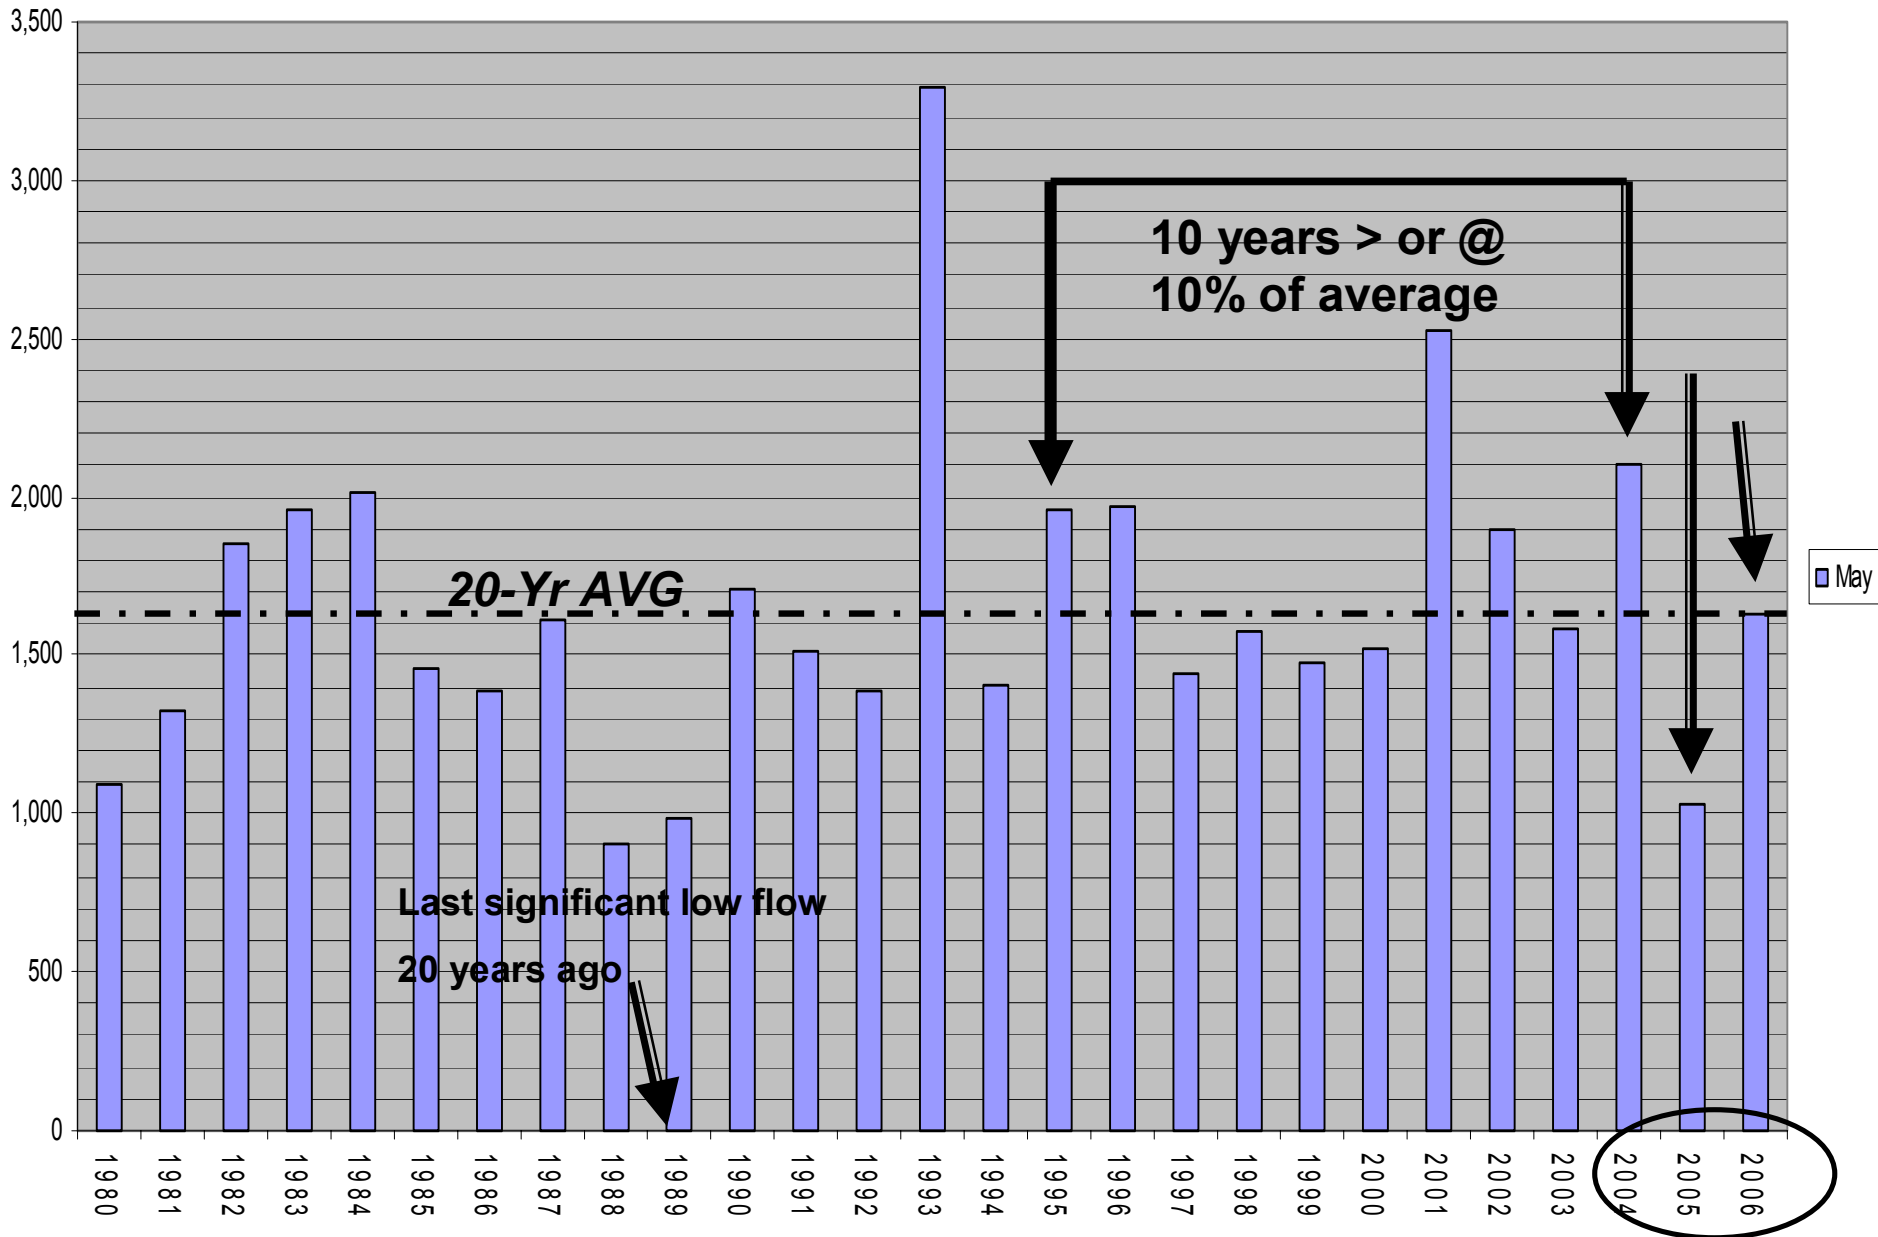
Fox Rvier Discharge at Berlin in May (cfs)

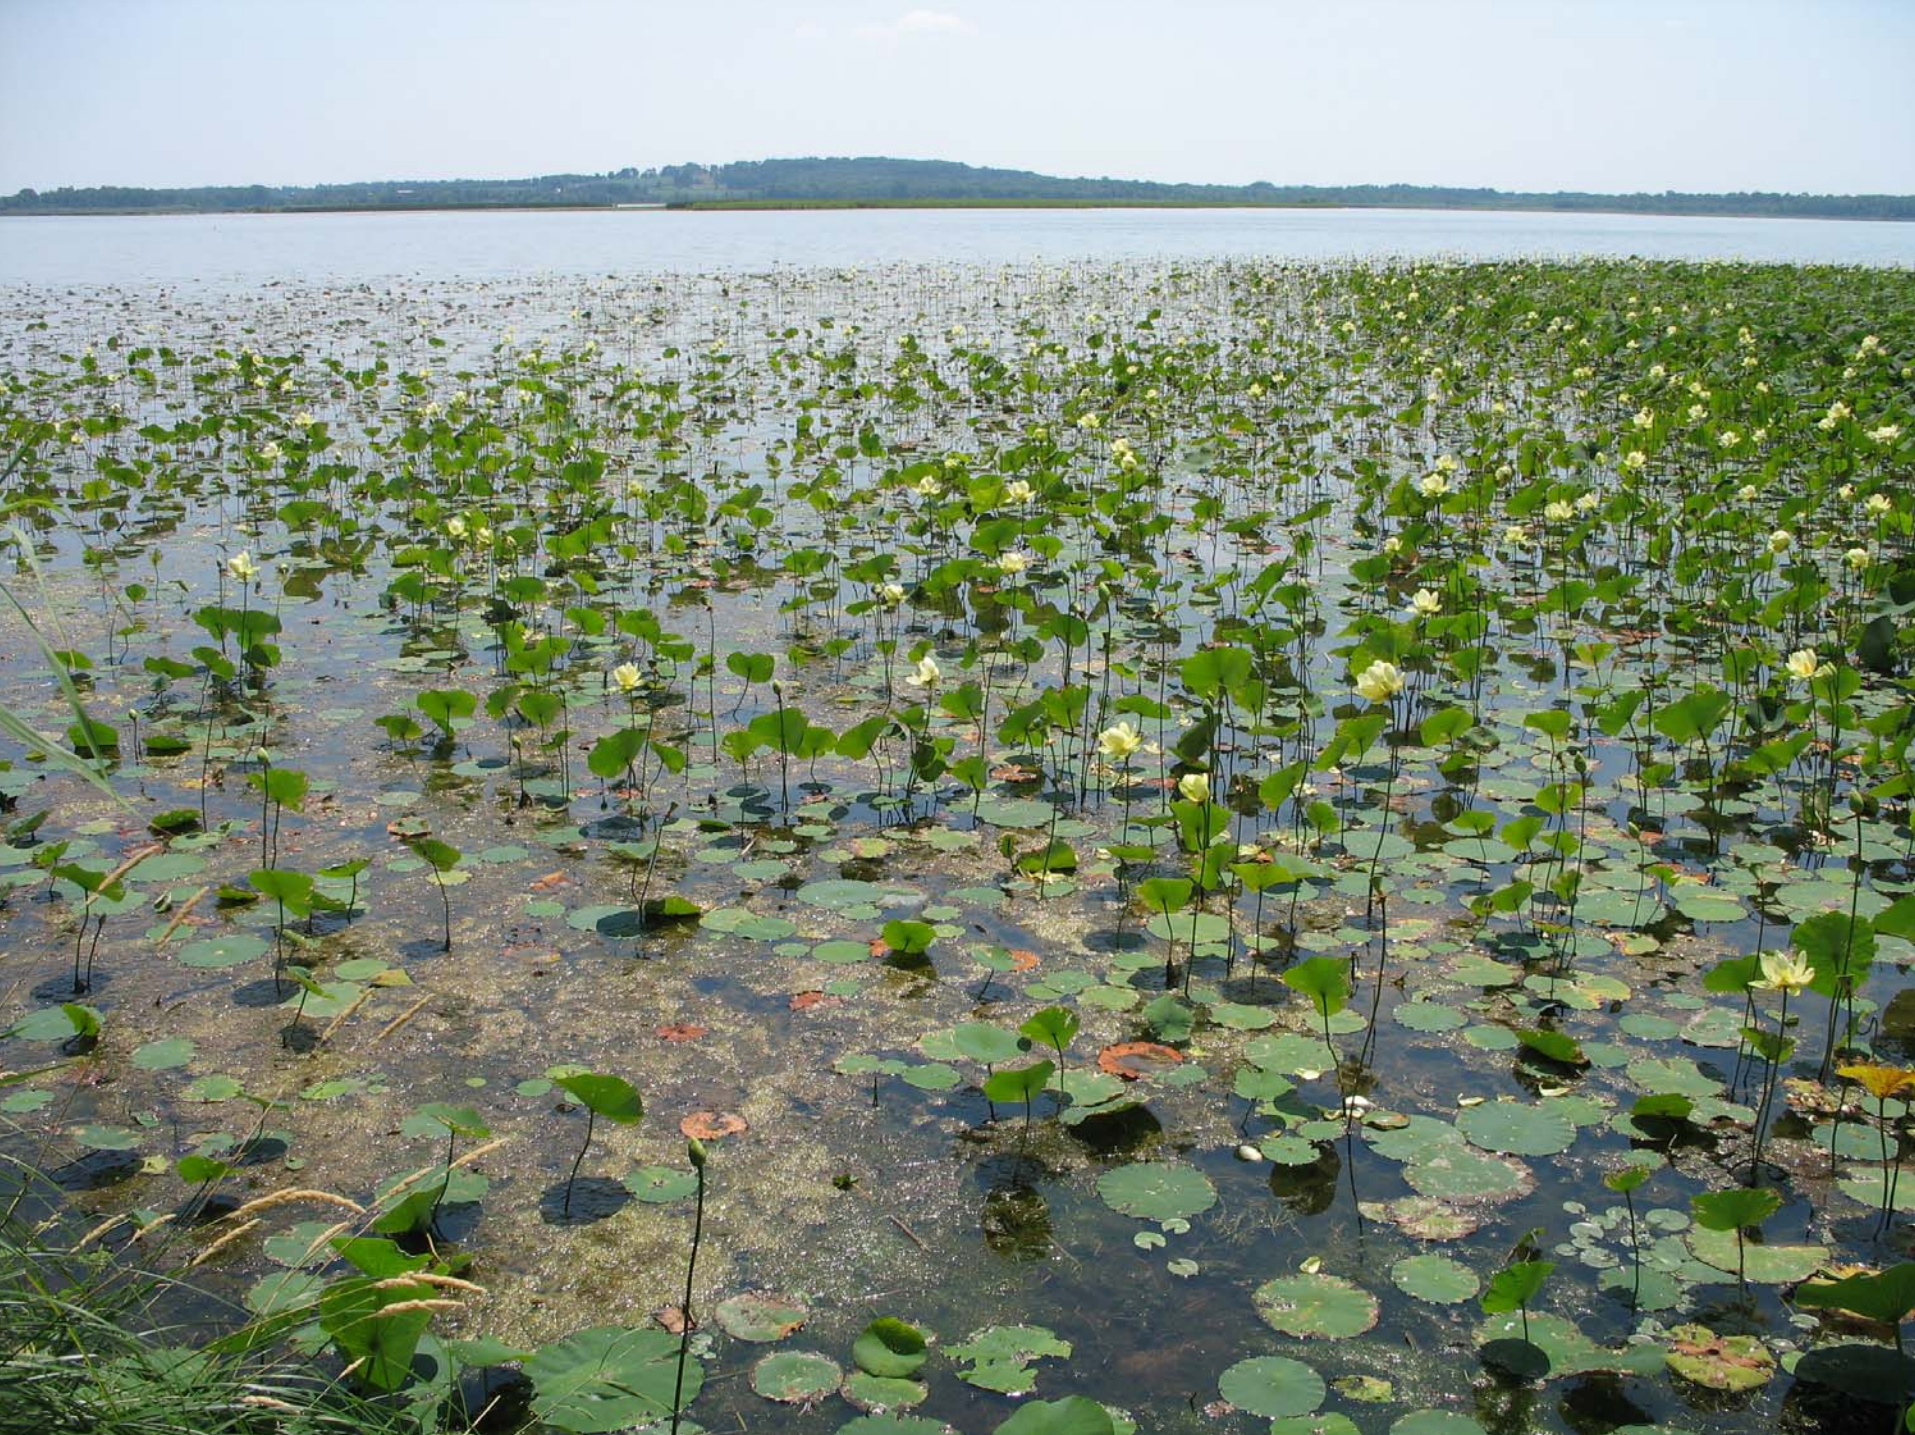
Dredge banks, once barriers to erosive waves, have dissolved and no longer protect the shorelines or emergent vegetation.

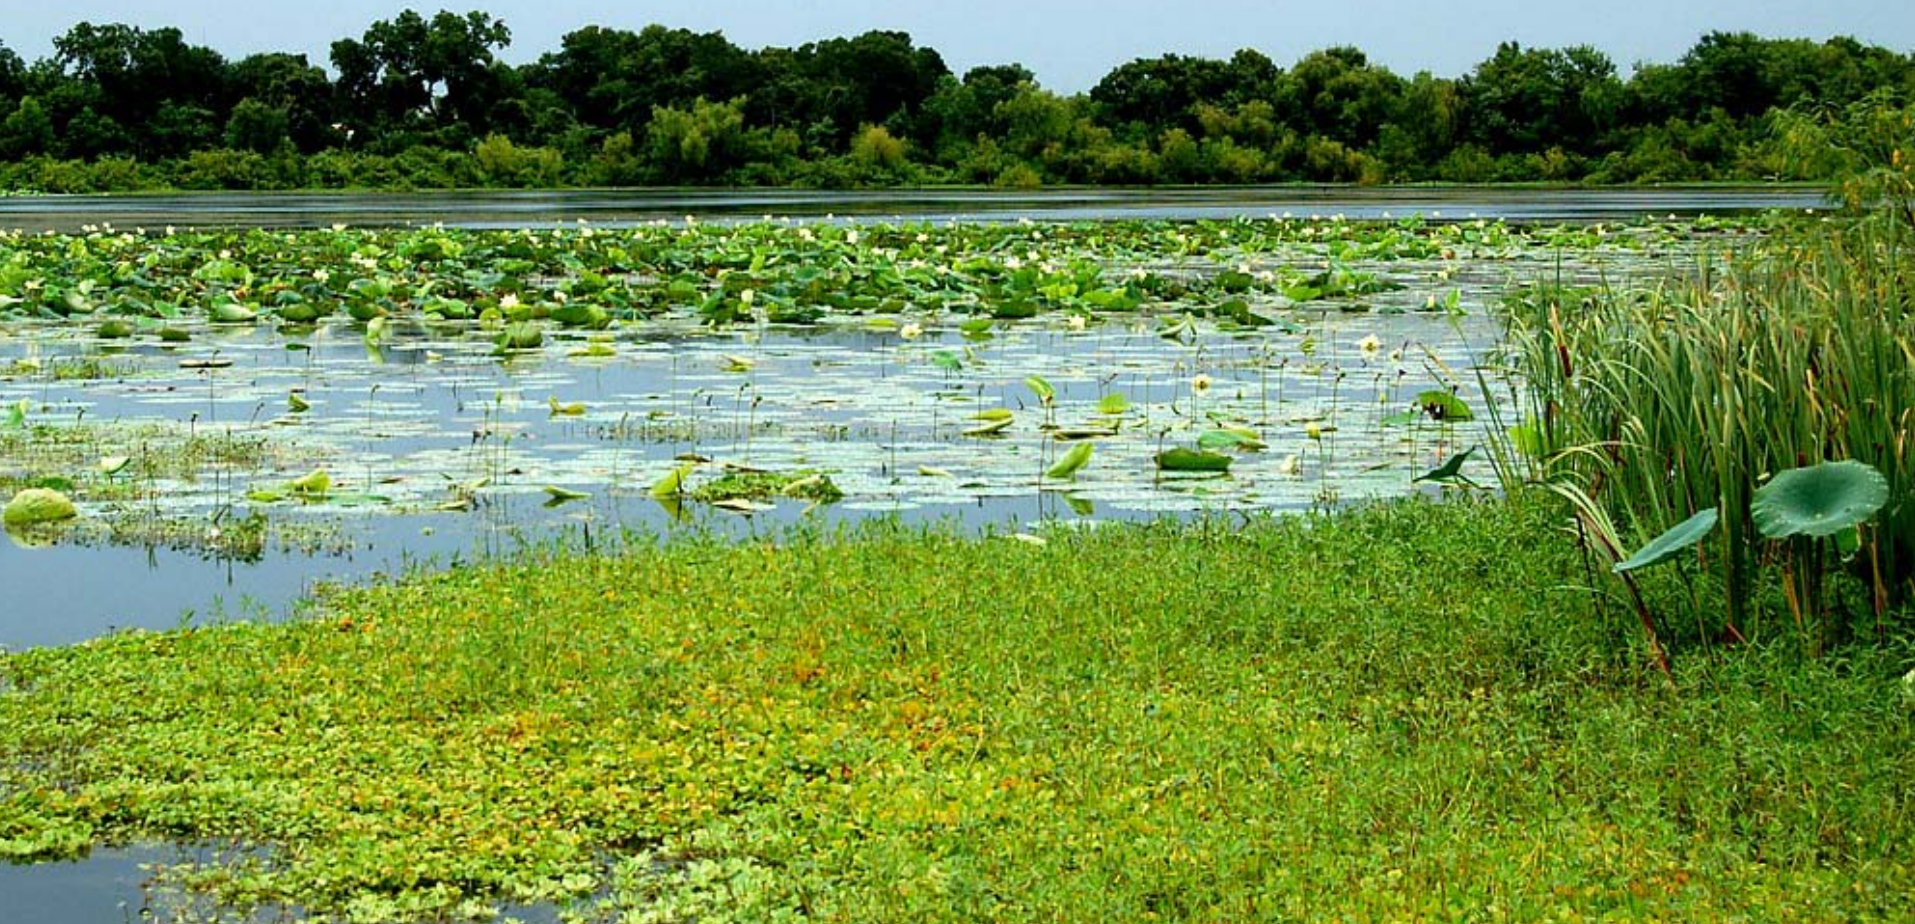
How do we Quantify the rate and amount of loss?

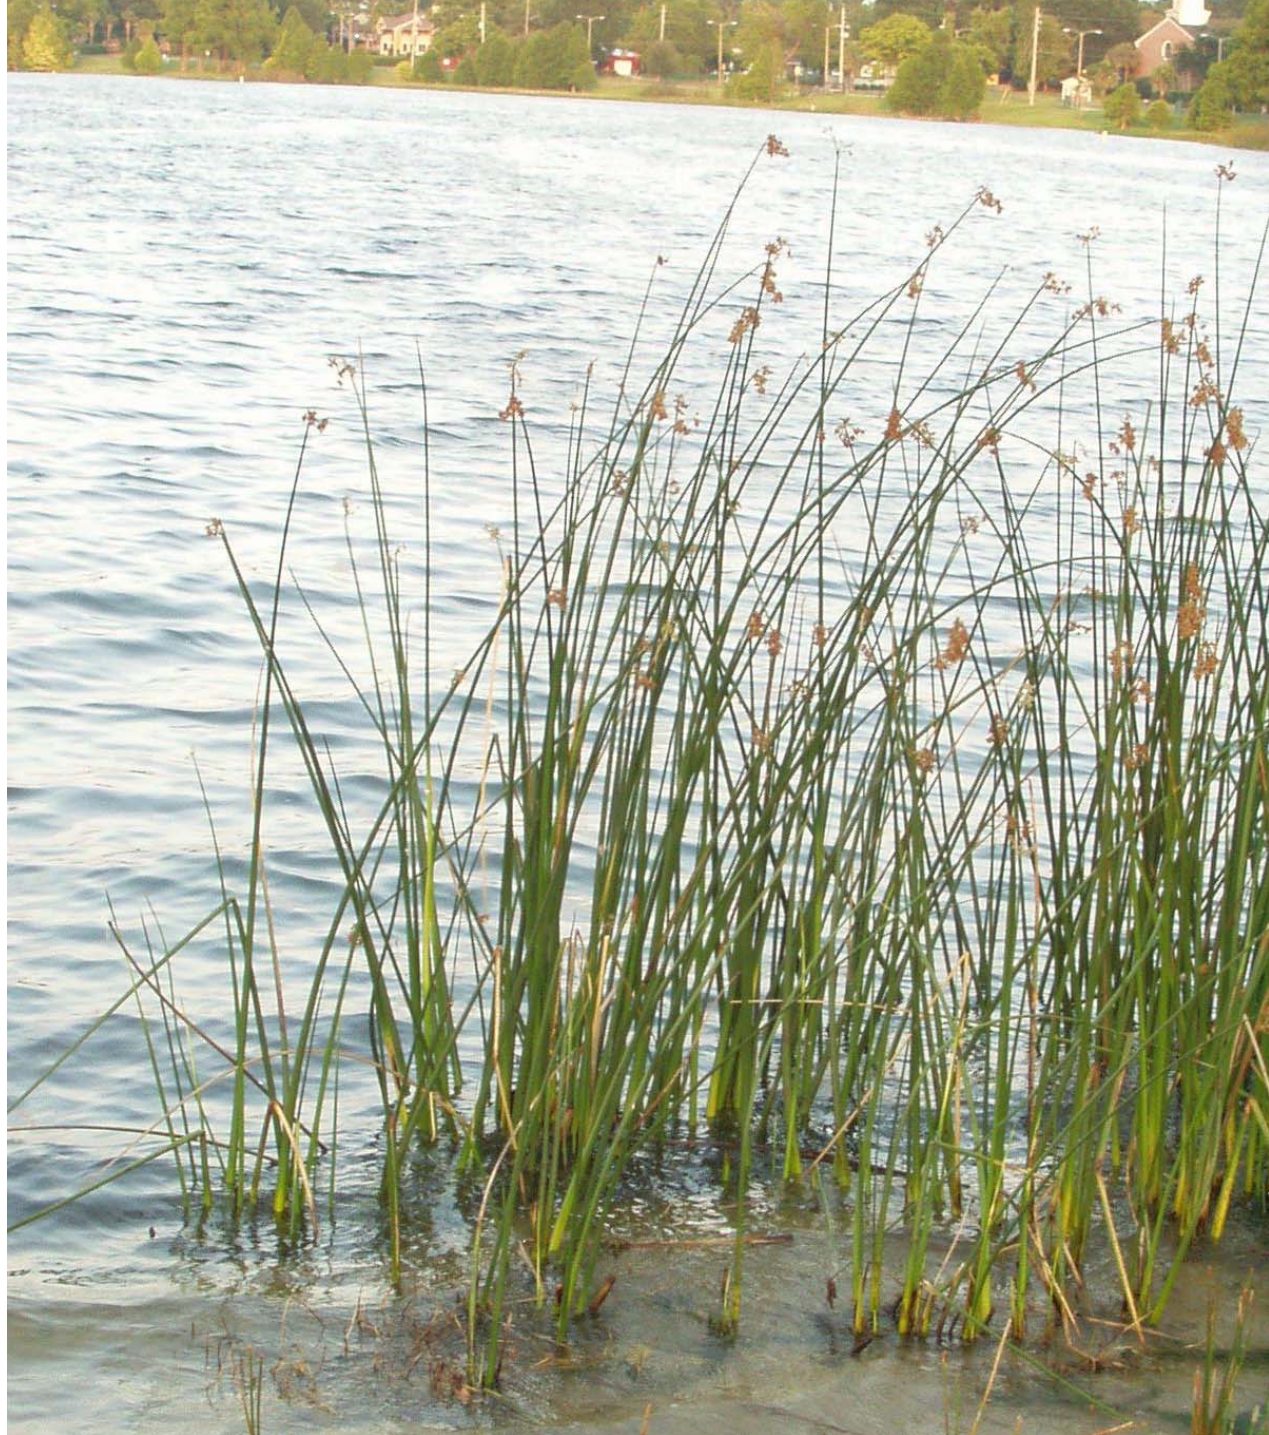
## Micro-Scale Analysis:

Establish set sample points throughout the lake and conduct a plant survey annually at the same location.

Use GPS to delineate edge of emergent plant beds for comparison over time.

Begin monitoring in 2010.
