Green Lake County's Inspection Report

1. Type of Inspection (check all that apply) ☒ Annual ☐ Major Storm ☐ Site
2. Date of Inspection: 10/29/2025
3. Drainage District Name or Number: Seneca-Warren
4. Location of Damage or Complaint:
Looked at Junction of Town Drain and Lateral A, concern from Mike Eagan that his water cannot get into the Town Drain to provide drainage.
5. Name of person(s) making complaint or accompanying the inspection:
Mike Eagen, not present for inspection

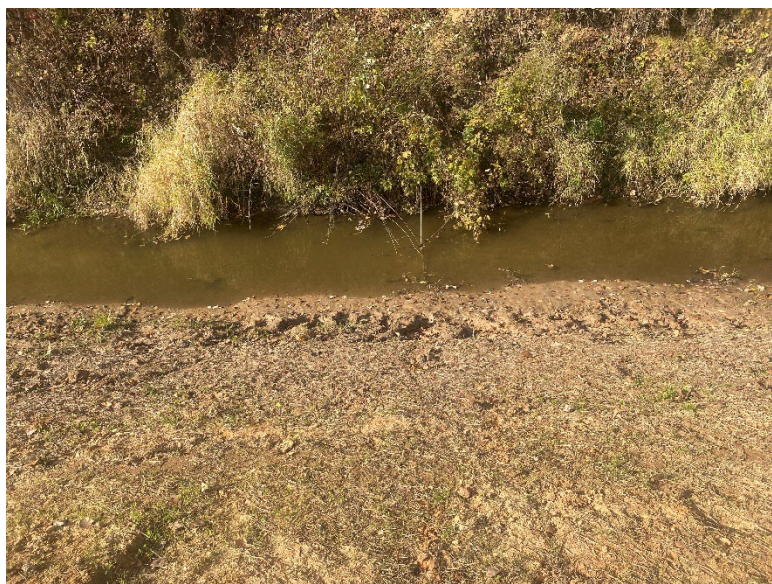
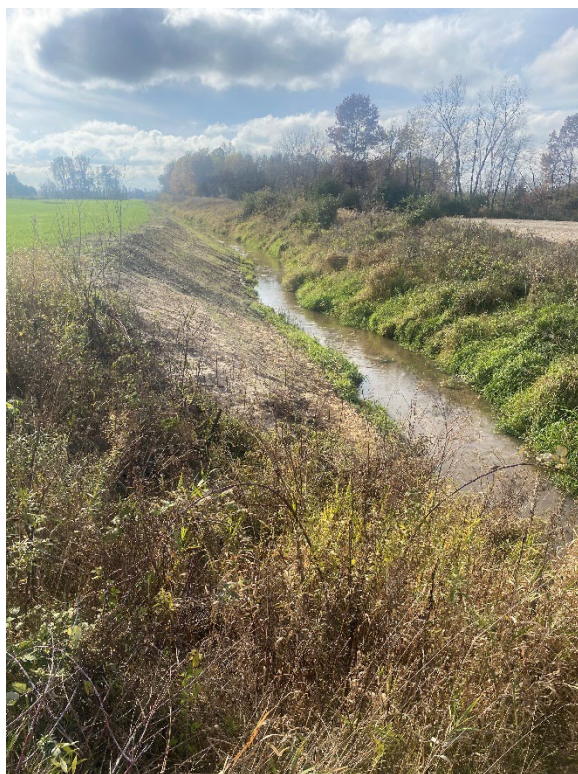
Ditch/Trees – along corridor (Guden property)

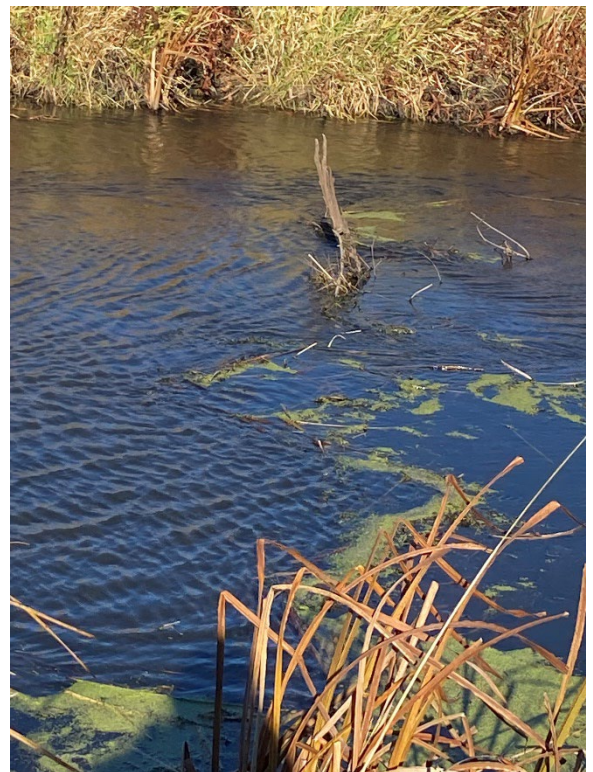
Town Drain inspection – East of Hwy D (Kujawa access point)

No grass found in Town Drain.

Tree in close to where dam was last year. Water is flowing. Some debris here and there. Water flowing ok. Zietlow did not see any wild rice blockage.

Zietlow counted 25 trees from access to where south ditch bank is washed through, not plugged upstream from improved dike. There has not been any work on South bank except to plug two holes. Water can still flow through major washout in south bank and is then trapped south of ditch corridor.
