**2011 AIS TREATMENT
POST TREATMENT SURVEY
TWIN LAKES
GREEN LAKE, WISCONSIN**

FIGURE 1
2121-11005-0
Date of Survey:
7-16-2011

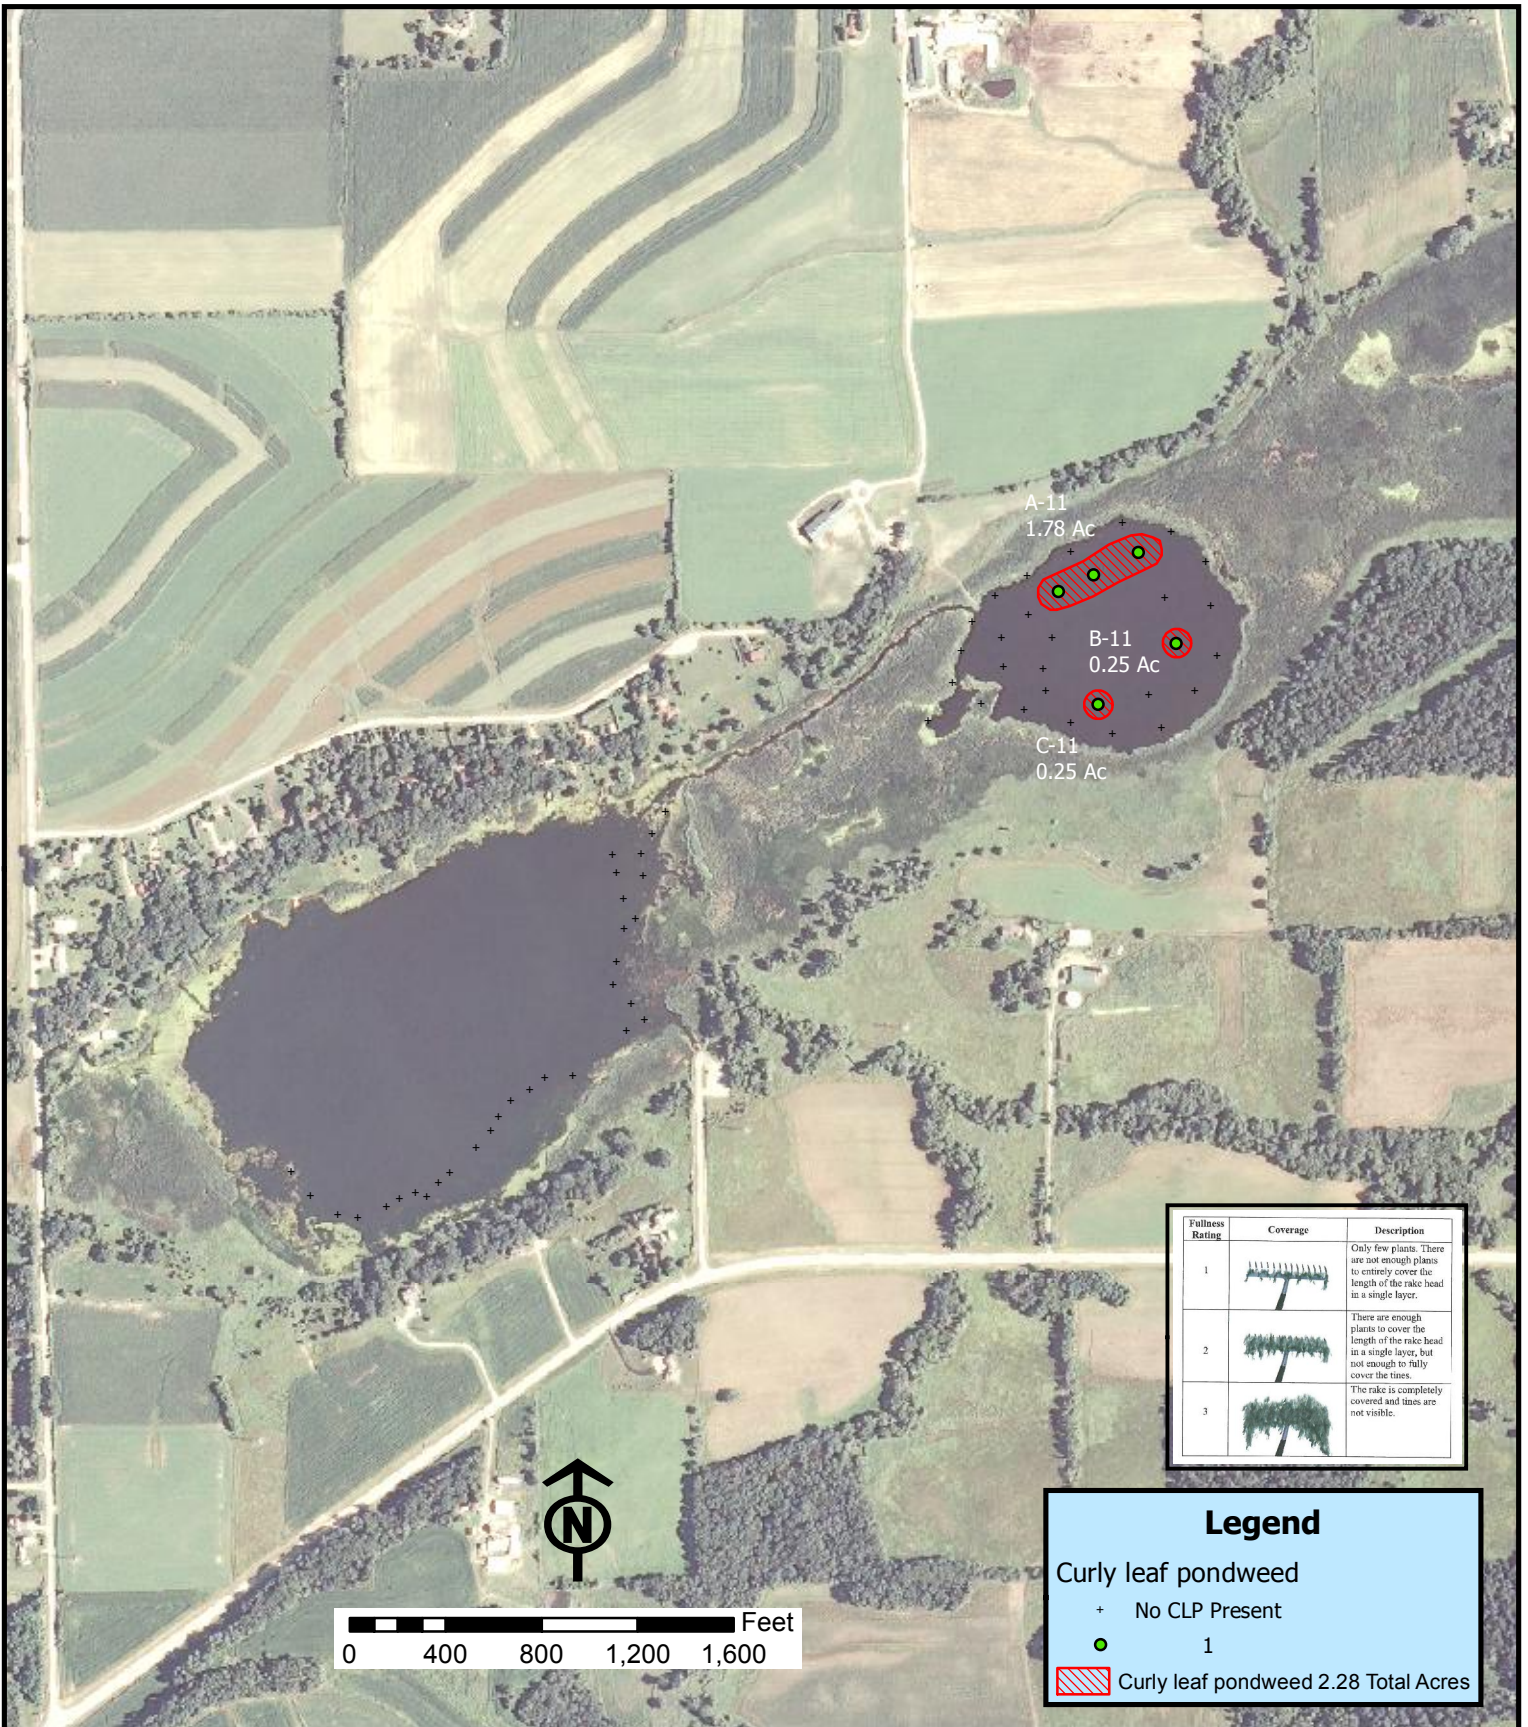
Fullness Rating	Coverage	Description
1		Only few plants. There are not enough plants to entirely cover the length of the rake head in a single layer.
2		There are enough plants to cover the length of the rake head in a single layer, but not enough to fully cover the tines.
3		The rake is completely covered and tines are not visible.

- + No CLP Present
- 1
- Curly leaf pondweed 2.28 Total Acres
